***AN ARCHAEOLOGICAL EVALUATION  
OF 41BX784 A HISTORIC HOMESTEAD  
IN BEXAR COUNTY TEXAS***

***Brazos Valley Research Associates  
Contract Report Number 162***

***March 2006***

BVRA Project 06-02

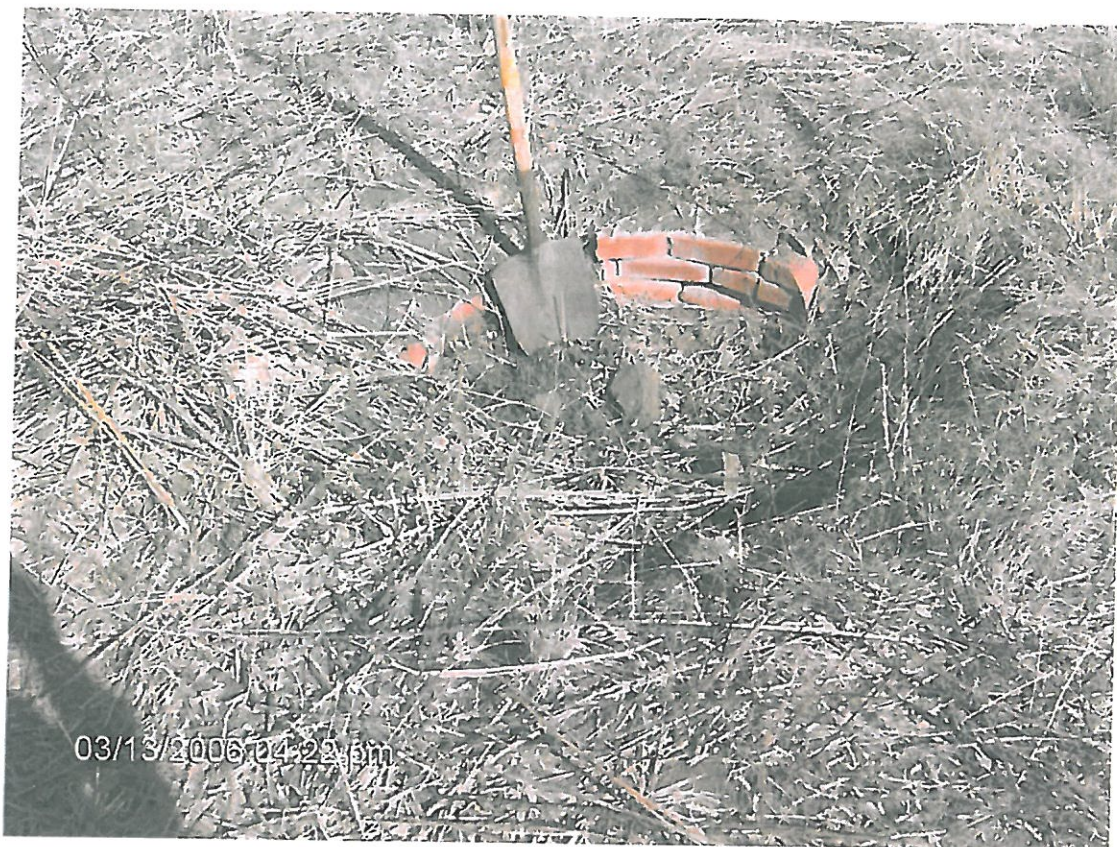
Figure 5. Feature D

Brick-lined cistern (4 feet in diameter). This cistern was filled in with dirt. No artifacts were observed in or around this feature (Figure 5). The bricks were identified as Williams. A plastic pipe was observed near feature, and it may have been used as a replacement for an earlier iron inlet pipe. Voellinger observed this feature.

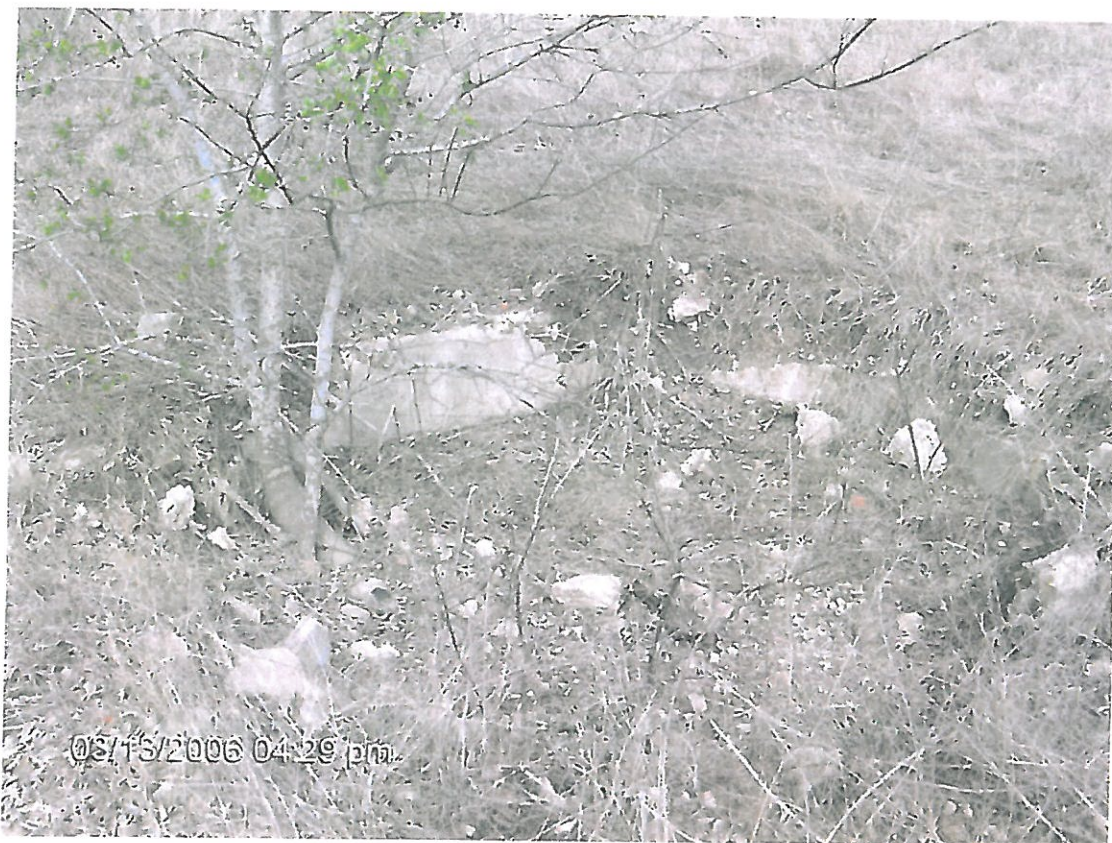
Figure 6. Feature E

Circular brick water trough (8 feet in diameter) (Figure 6). This trough was lined with brick using Portland mortar and plaster and filled in with dirt. No artifacts were observed in or around this feature. The bricks were identified as Alamo. BVRA believes this is one of the cisterns observed by Voellinger.

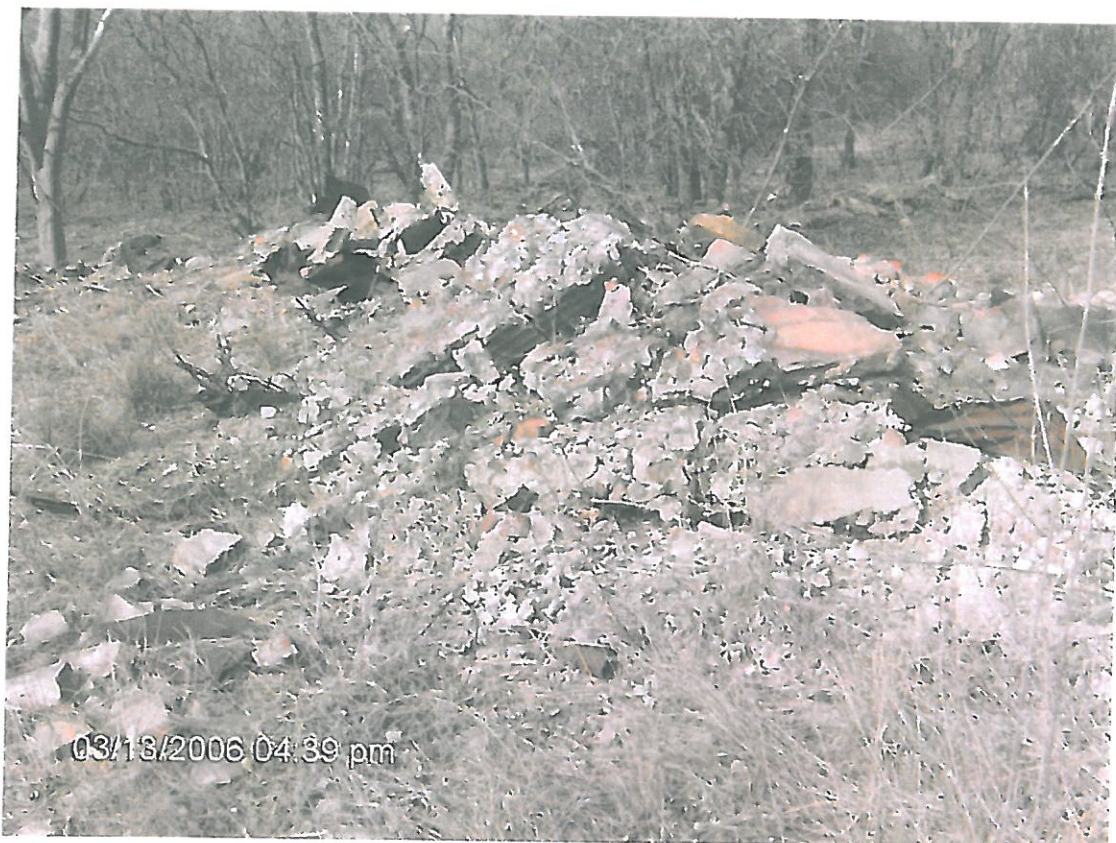
Figure 7. Feature G

Concrete and brick rubble pile (40 feet in diameter) (Figure 7). Based on the presence of fire brick (D'Hanis and Loclede St. Louis), a firebox with a chimney was once present at this location. The size of the rubble pile and the presence of the brick suggests this was the location of a residence. BVRA believes this is one of the rubble piles observed by Voellinger.

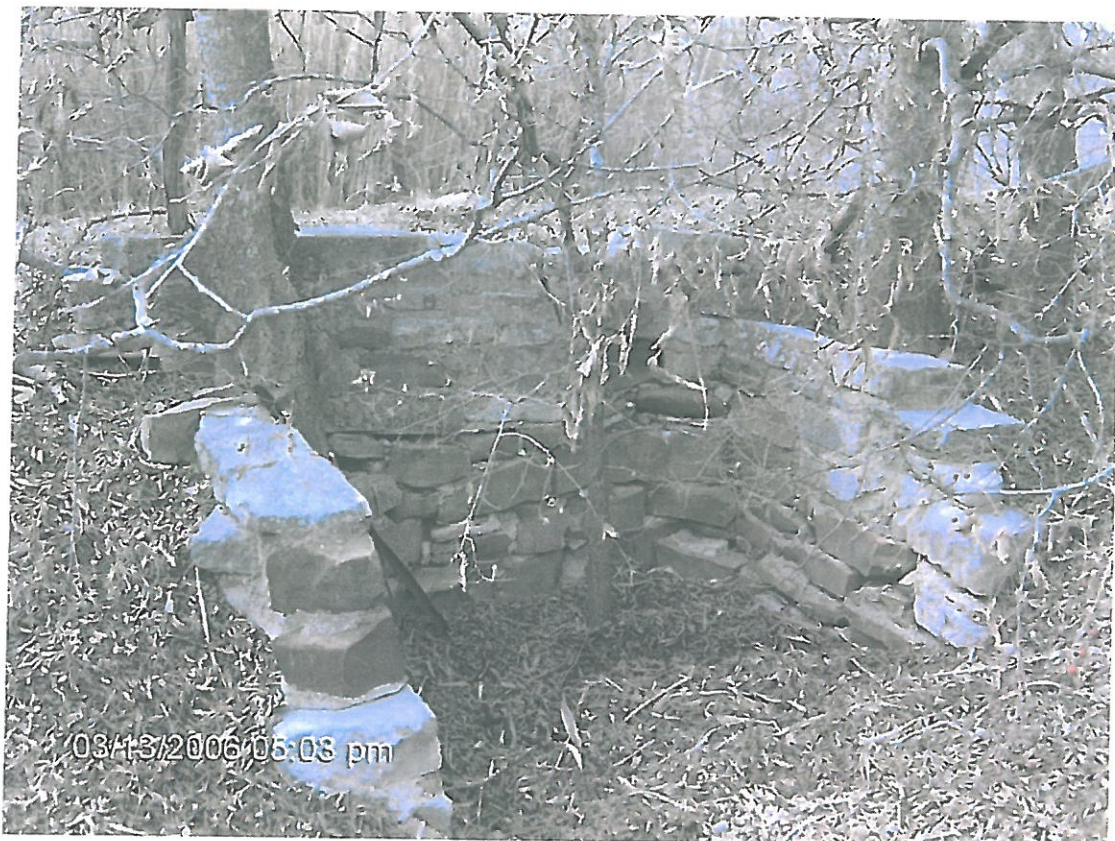
Figure 8. Feature N

Sandstone structure plastered with Portland cement (Figure 8). It is approximately 8 feet x 8 feet in plan and 5 feet tall. It was built into an earthen embankment below the two earthen ponds. The hackberry tree to the left was already in place when the feature was constructed; otherwise, there would be cracks or movement of the left wall. This feature is not believed to be very old because of the use of Portland cement and the absence of mold or fungus on sandstone that occurs over time. It did not appear to be weathered. The function of this unusual feature is unknown. Voellinger does not mention this feature.
